Manhole Inspection Summary

Manhole # S49A__011MH

Location Address: **rear 437 n luzerne ave**

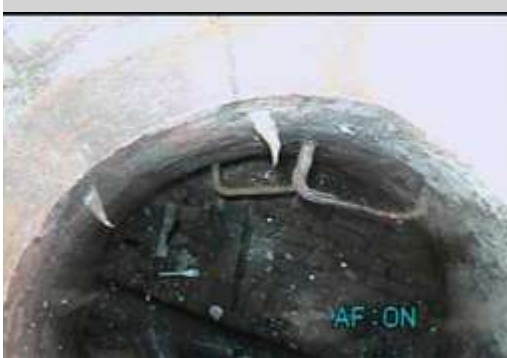
Defect 2

Steps Count: **3** Missing: **1** ☒ **Corroded**

steps

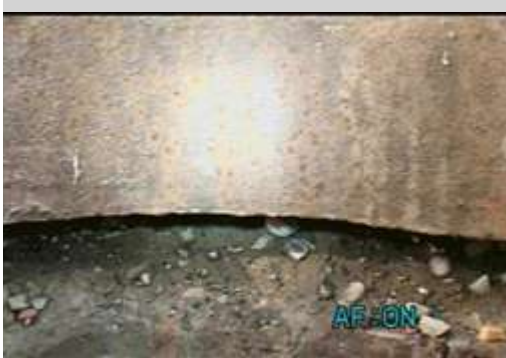
Defect 1

Condition: ☐ Sound ☐ Cracked ☐ Root Intrusion ☐ Loose Brick ☒ **Deteriorated**

CHIMNEY_COND_DETERIORATED

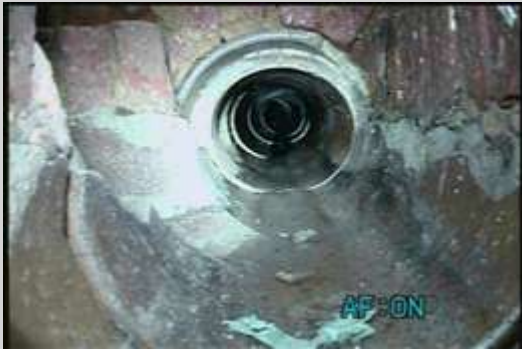
12 O'Clock Outflow

8 in. Circular Gravity Sewer
Pipe Out @ 12 O'Clock

Infiltration: **None** Pipe Seal Cond: **Unknown**

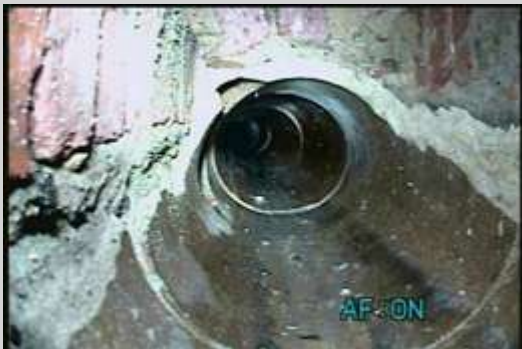
6 O'Clock Inflow

8 in. Circular Gravity Sewer
Pipe In @ 6 O'Clock

Infiltration: **None** Pipe Seal Cond: **Unknown**

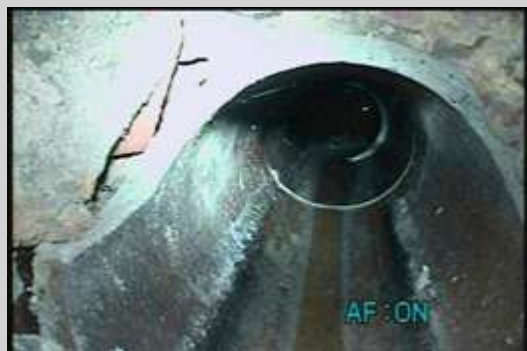
9 O'Clock Inflow

Infiltration: **None** Pipe Seal Cond: **Unknown**
